USB-Port Configuration: Alternative 1

(EFI/OC/ACPI/SSDT-UIAC-USB-Z490-VISIOND-ALTERNATIVE-1.aml)

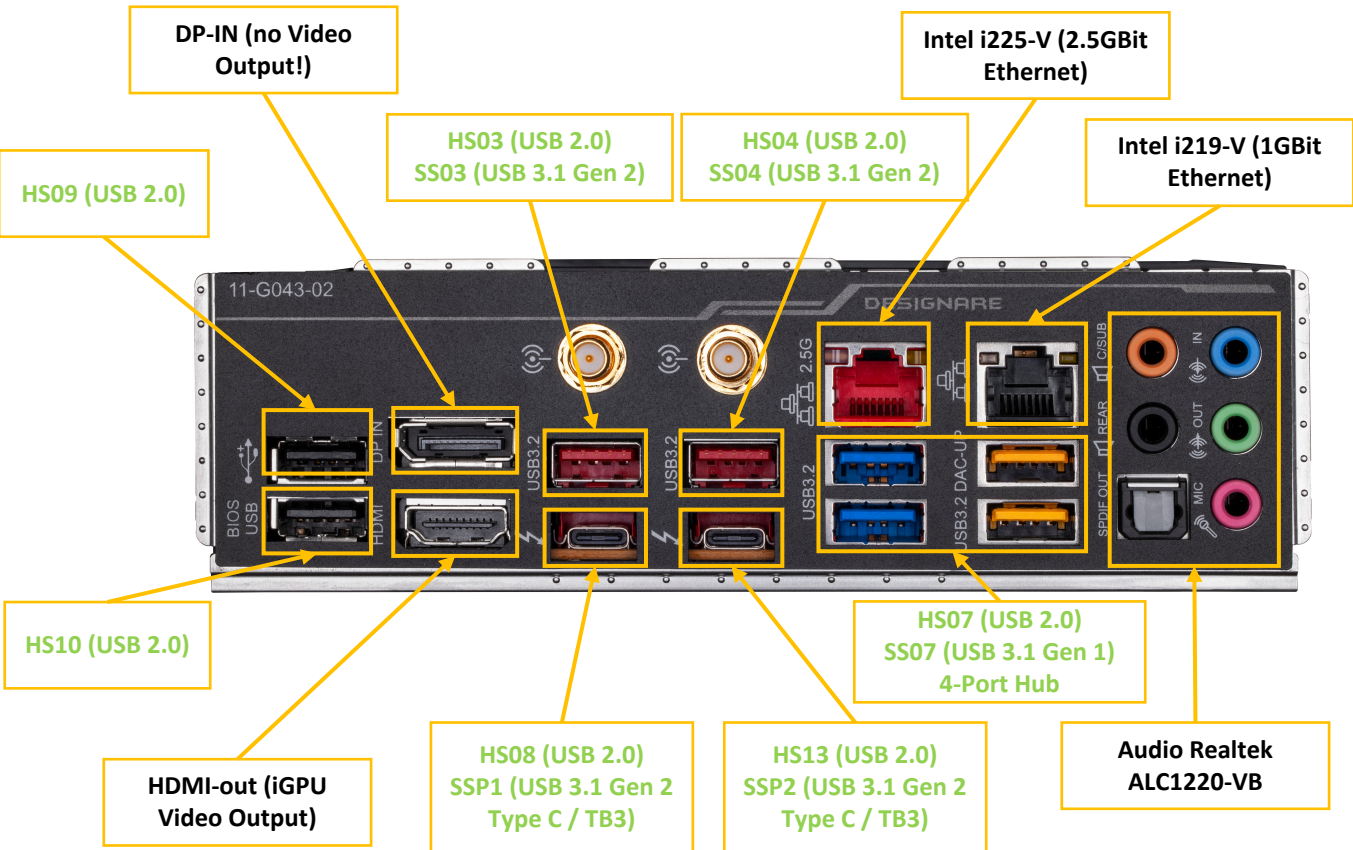
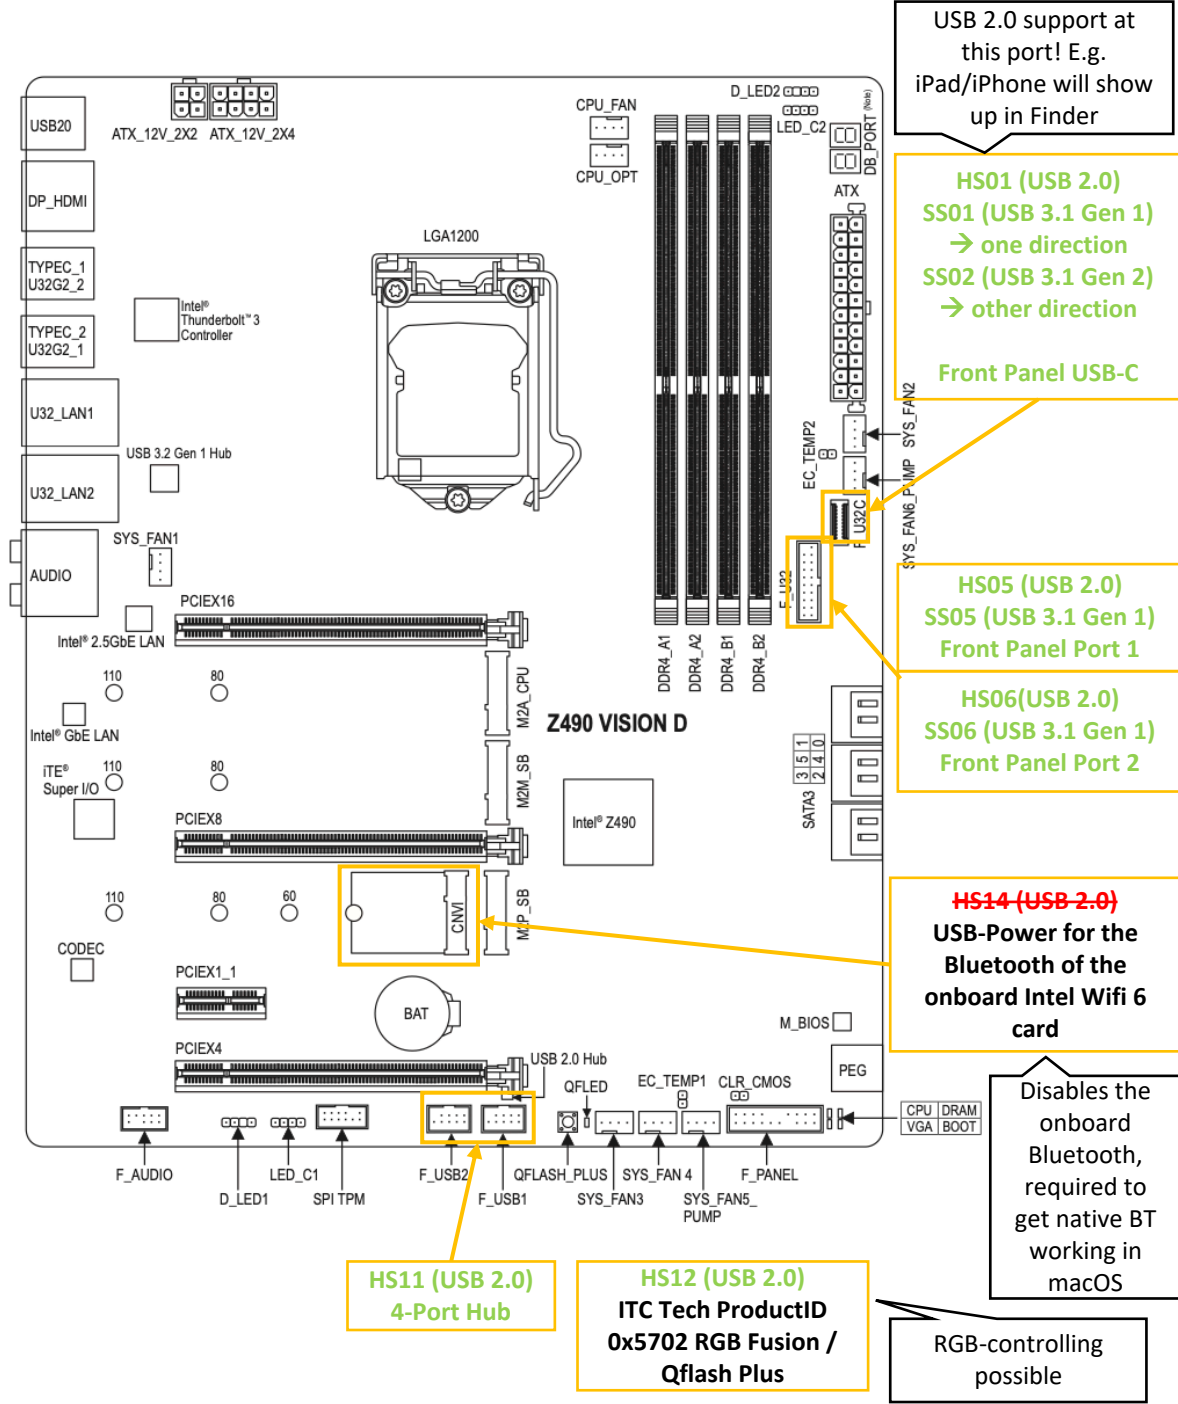
USB-Port Configuration: Alternative 3

„No limits: All ports work but needs OpenCore USB-patch *Kernel/Quirks/XhciPortLimit =Yes* to exceed macOS 15 USB-port limit.“

12x HSxx ports (USB 2.0 capable)
7x SSxx ports (USB 3.1 capable)
→ In Total 19 ports

2x SSPxx ports (Thunderbolt ports) → don't count within the 15 port limit
